## ADVANCE CEM

Subject: Logic Change  
 IBM 729 NOR - Machines with JT 85180 V  
 (B/M's 8023445 and 8026561)  
 See Advance CEM dated August 11, 1964

Subject: Tape Drive Tester - Power Cable

TO : COUNTRY CE MANAGERS OR FIELD SERVICE GROUP MANAGERS

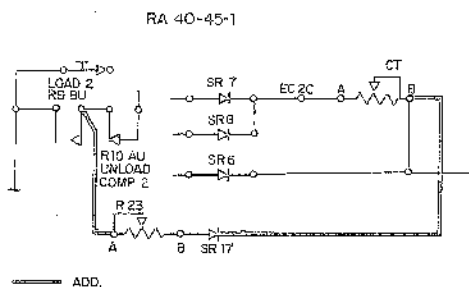
#### ECR 90028

Location of R23 - Hole CP12 on the CP panel  
Location of SR17 - above SR15.

In order to standardize all the machines, apply the following modifications.

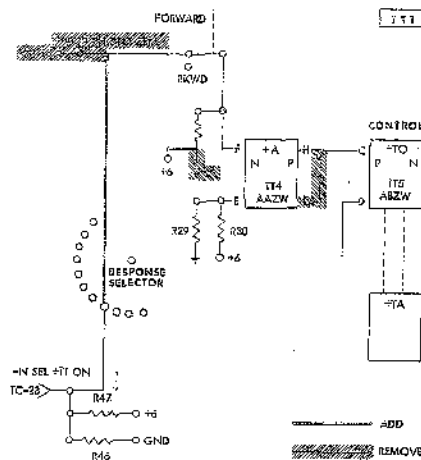
With the tester modified in this manner, 729 NORLAY tape drives and 729 Relay tape drives can be tested with or without using the CE Cable. If the CE Cable is not used, the indicator lamps will not be lit, and the following switches will be inoperative:

6. Remove  
-6 volt jumper from R19 to R23  
-6 volt jumper from R19 to R18

Add  
-6 volt jumper from R23 to R18  
+6 volt jumper from R19 to R17

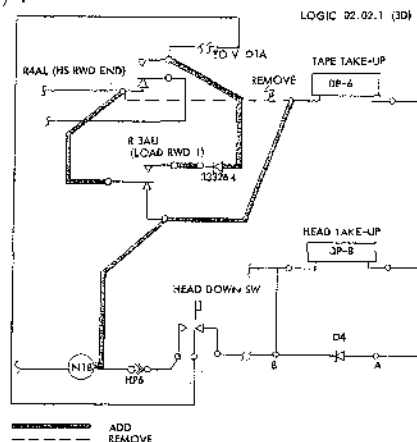
The above circuit will be installed by ECR 45-229 on all machines leaving the plant, and subsequently will be picked up on EC 253520.

Add wire from	R4AL N/C to R3AU op
	R3AU N/C to DP6 pick
	R3AU N/C to NEON 18 (wire to head down switch)
Add diode from	R4AL N/O (plate ) to R3AU N/O (cathode)

Use any available diode normally used in back circuit elimination or arc suppression, such as a top-hat, AM type or small, two-plate selenium type. If diodes are not available, order P/N 333264 on Field Requisition Card code 6 from COP Only.

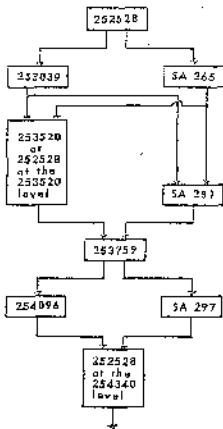
ECs 252528 and 253759 do not apply to NOR drives with pre-amps in the rear.

ow chart "B" is applicable to NOR drives with the pre-amps in the front. The problems and the required solutions when installing the ECs listed in the chart are as follows:

EC 252528 (CEM 93) was either factory or field installed. The first two sections of this change were incomplete. The update of this change and an additional improvement were combined into EC 253520 (CEM 116). EC 253520 (EC 252528 at the 253520 level) and Service Aid 281 (with ALDs from 253520) are equivalent. However, the point to point wiring of SA 281 and EC 253520 are not identical.

EC 254096 is now mandatory.

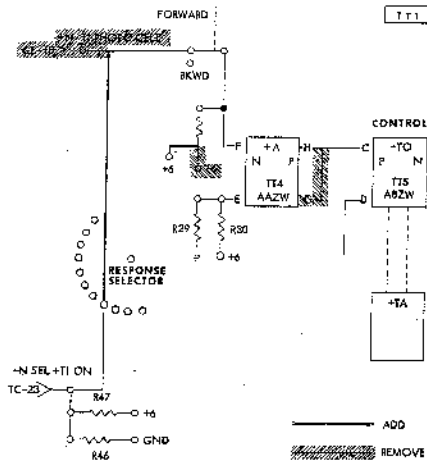
In the tester modified in this manner, 729 NORLAY tape drives and 729 Re-tape drives can be tested with or without using the CE Cable. If the CE Cable is not used, the indicator lamps will not be lit, and the following switch will be inoperative:

6. Remove  
-6 volt jumper from R19 to R23  
-6 volt jumper from R19 to R18

Add  
 -6 volt jumper from R23 to R18  
 +6 volt jumper from R19 to R17

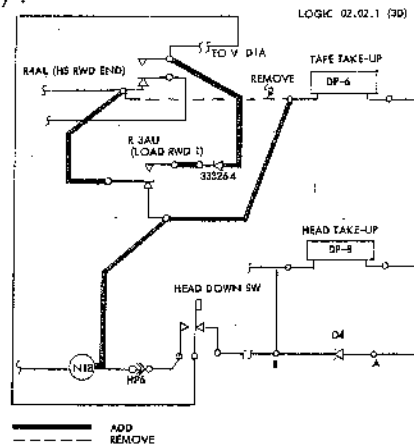
The above circuit will be installed by ECR 45-229 on all machines leaving the plant, and subsequently will be picked up on EC 253520.

Add wire from R4AL N/C to R3AU op  
 R3AU N/C to DP6 pick  
 R3AU N/C to NEON 18 (wire to head down switch)  
 Add diode from R4AL N/C (plate) to R3AU N/C (cathode)

Use any available diode normally used in back circuit elimination or arc suppression, such as a top-hat, AM type or small, two-plate selenium type. If diodes are not available, order P/N 333264 on Field Requisition Card code 6 from COP Only.
