## ADVANCE CEM

Subject: Logic Change  
 IBM 729 NOR - Machines with JT 85180 V  
 (B/M's 8023445 and 8026561)  
 See Advance CEM dated August 11, 1964

Subject: Tape Drive Tester - Power Cable

TO : COUNTRY CE MANAGERS OR FIELD SERVICE GROUP MANAGERS

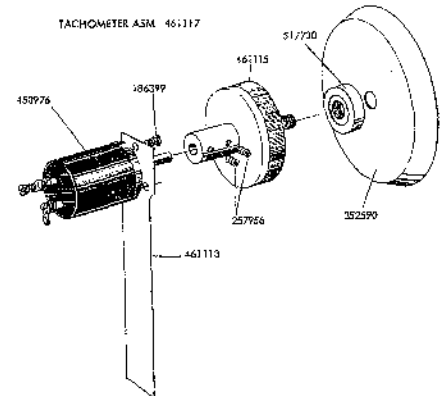
P/N 461117

A tachometer generator will be needed to make the necessary magnetic clutch current adjustments on 729 II and IV Relay machines with B/M 8018597 - see CEM 729 EC 79 (68) and 729 NOR Machines Models IV or VI.

The figure below shows the parts necessary to mount the tach-generator in place of the cover and handle of the Quick Release Reel Latch.

Replace the Quick Release Reel Latch cover and handle (P/N's 5344951 and 5344954) with cover P/N 352590, Bearing P/N 517730 and the tach-generator assembly P/N 461117. Connect tachometer to oscilloscope with a direct probe. Scope setting; 1 volt/cm 50 ms/cm sweep.

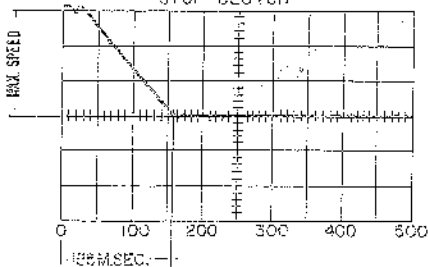
TYPICAL CLUTCH RESPONSE CURVES  
STOP CLUTCH

1. Up or down clutch must obtain 2/3 maximum speed in 0.140-0.150 seconds, with full reel of tape.
2. Stop clutch must stop a full reel of tape from full speed in 0.150-0.160 seconds. See graphs below.

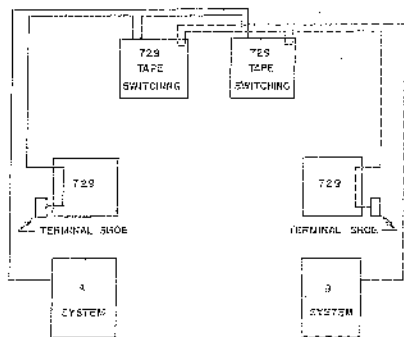
The Signal Lines for each system must be terminated at a tape unit that has power on.

The sketch below illustrates one method of connecting the Signal Cables and Terminator shoes so that the system may operate while power is down on the other system.

In this case, of course, if we suppose that each system powers two 729's, and the power is down on system B, only the two 729's on the left can be used with the system A.

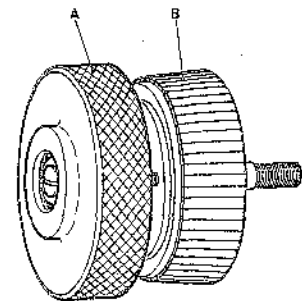
P/N 8018462

A new tool has been developed to perform the adjustment of the partial brake during HS Rewind (to prevent Tape Wrinkle).

The principle of operation of this tool is similar to the one of a torque wrench. It is constituted by a knurled disk (A) mounted on a reel knob assembly (B). The disk (A) drives the knob (B) by means of a cam,
